The Workmen's Village and Production at Amarna

The Great Heresy: Egypt in the Amarna Age

Elizabeth Murphy

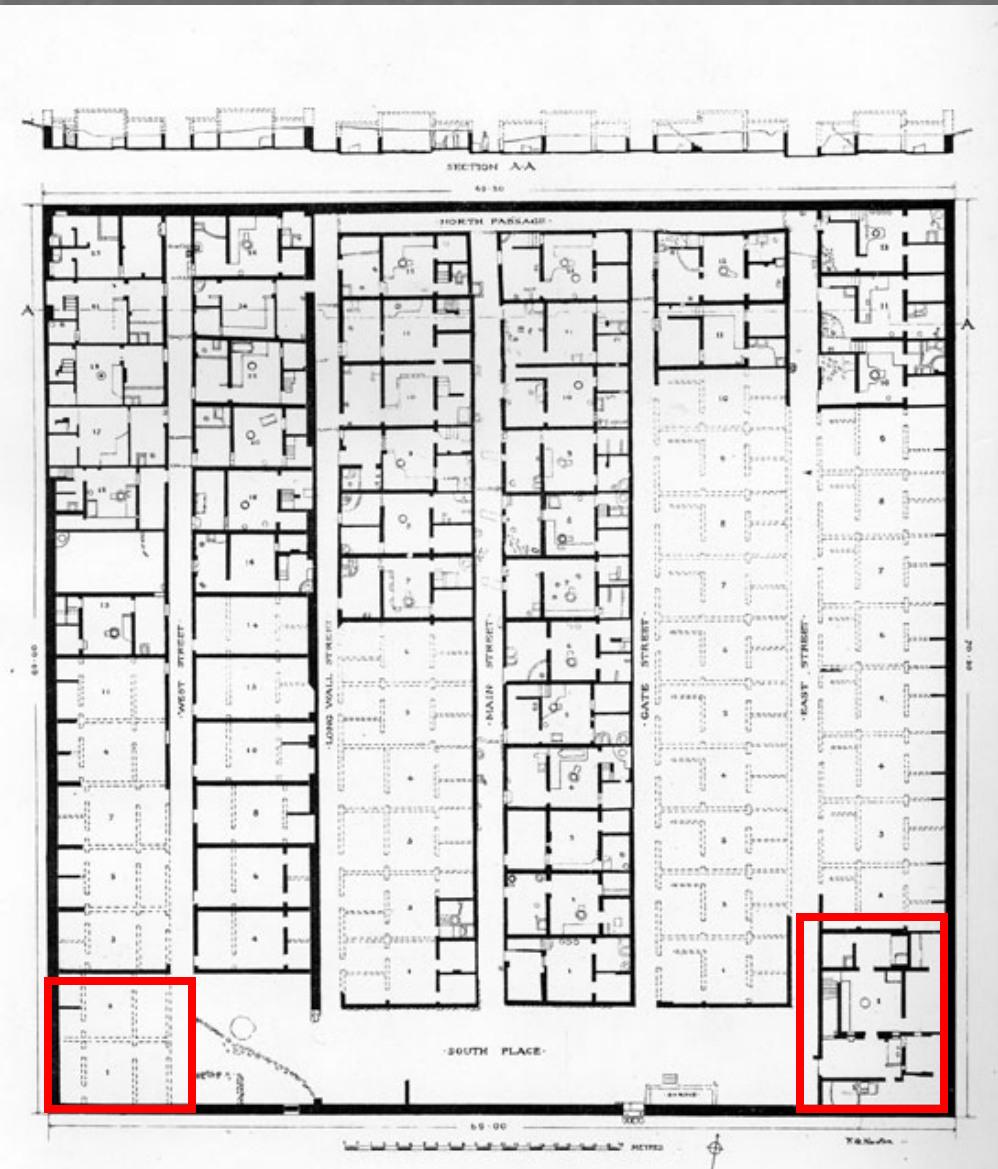
- Two Phases of Construction
 - Western addition
- 72 houses of same size and general layout
 - (equal status of workmen)
- 2 of greater size
 - overseers

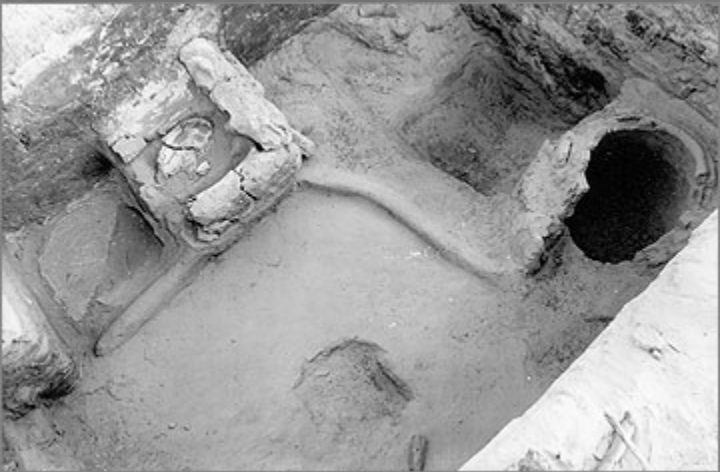
Plate 3 A cylindrical oven from the Amarna Workmen's village. The upper section has been lost. This example was not found in a house but in an annexe of the Main Chapel (Kemp 1987: 56); its size and construction, however, are the same as ovens found in the village houses. It consists of a ceramic cylindrical liner about 3 cm thick, surrounded by a substantial casing of mud brick and mud plaster. Some centimetres above floor level a small air vent, about 10 cm in diameter, pierces both wall and clay lining. This particular oven was built over a thick layer of ash and charcoal produced from another oven in the same room. (Photo by the author, courtesy of the Egypt Exploration Society.)

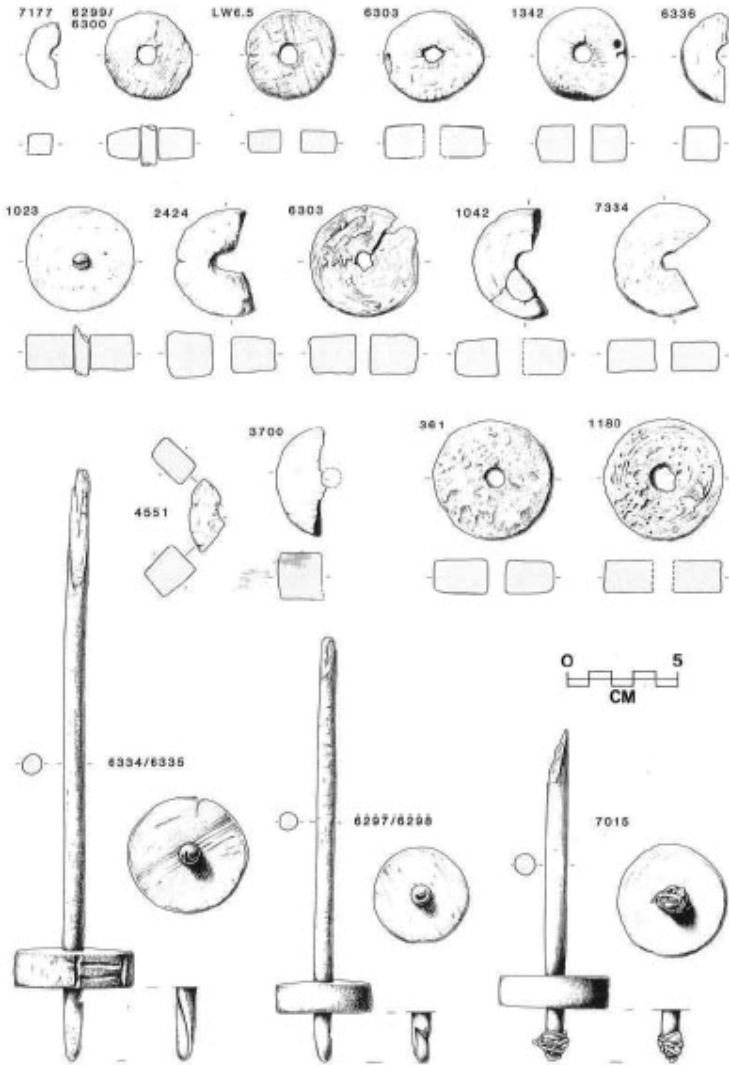
Figure 8.2. Drawings (by A. Boyce) of a selection of wooden spindles and whorls from the Workmen's Village.

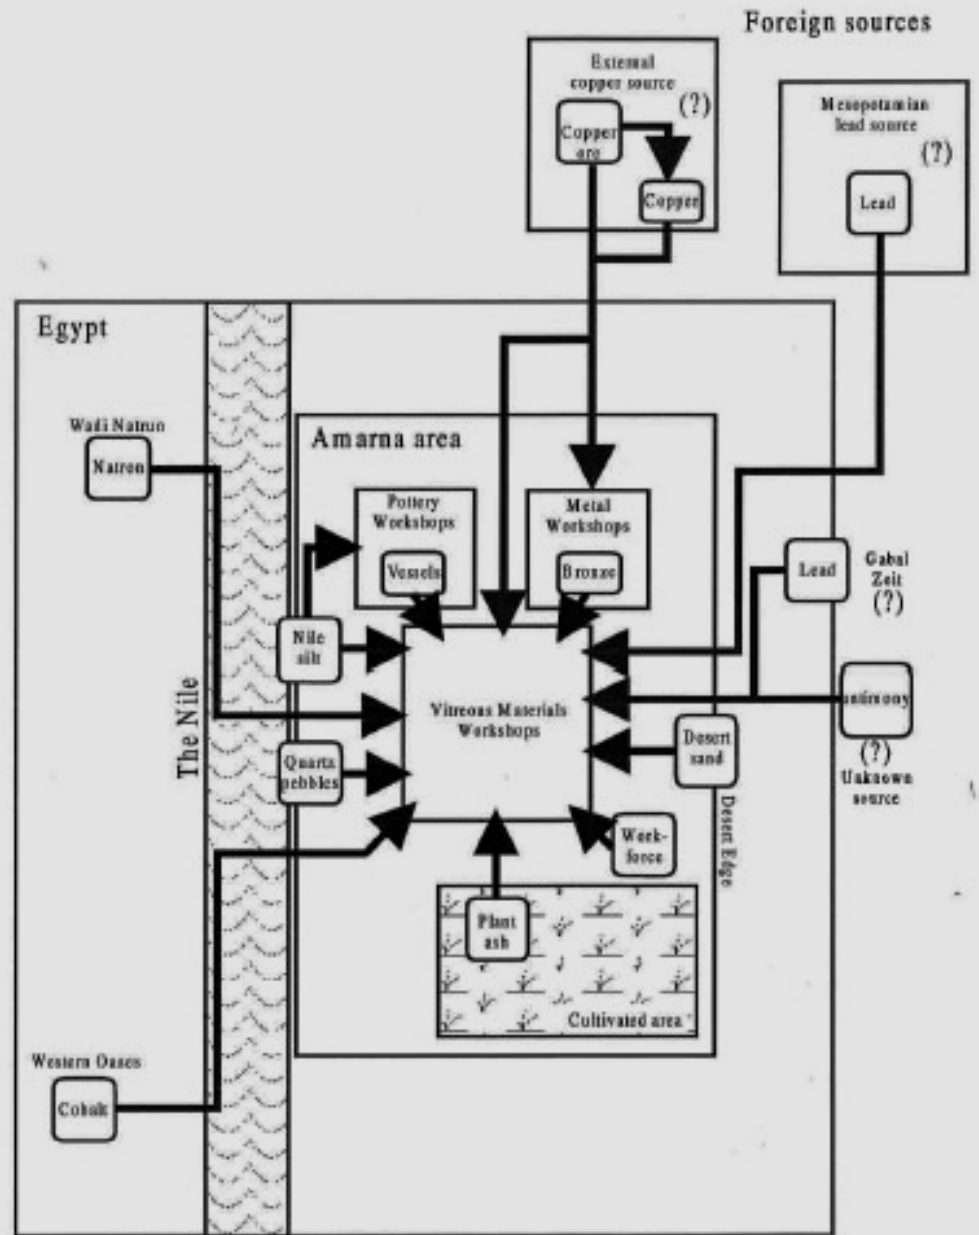
Figure 5-15 : Summary of the sources of the raw materials for the Amarna vitreous materials workshops. All sources within the square marked "Amarna" are those thought to be within the precincts of Akhetaten, those in the square marked "Egypt" under the control (to a greater or lesser extent) of Egypt, those outside this are foreign imports.

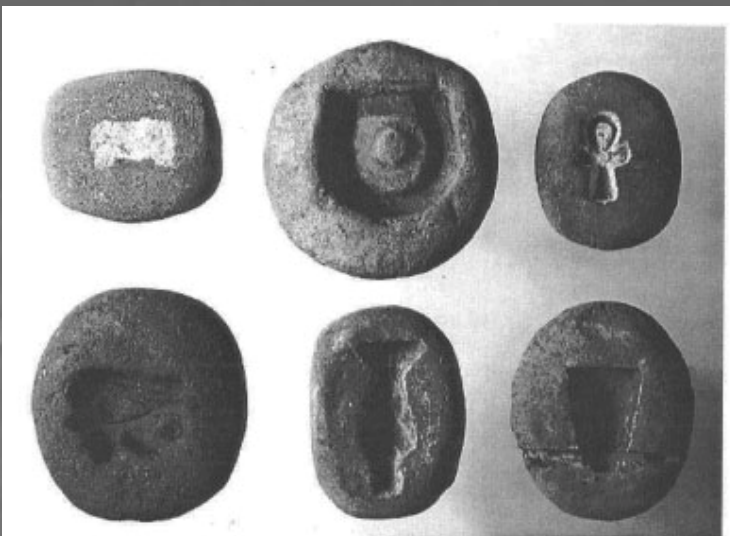
Figure 7-6 : Fired clay moulds for the making of small faience objects. Moulds such as these were found widely over Amarna by all excavators, although the current study suggests they tend to cluster around faience making areas. Clockwise from top left: a mould still filled with faience paste, mould for a ring shank, for an ankh amulet, a lotus bud, a thistle head and a wadjet eye. Copyright of the Petrie Museum of Egyptian Archaeology, clockwise from top left, UC 23959, UC 25137, UC 24042, UC 24221, UC 23911 and UC 1942.

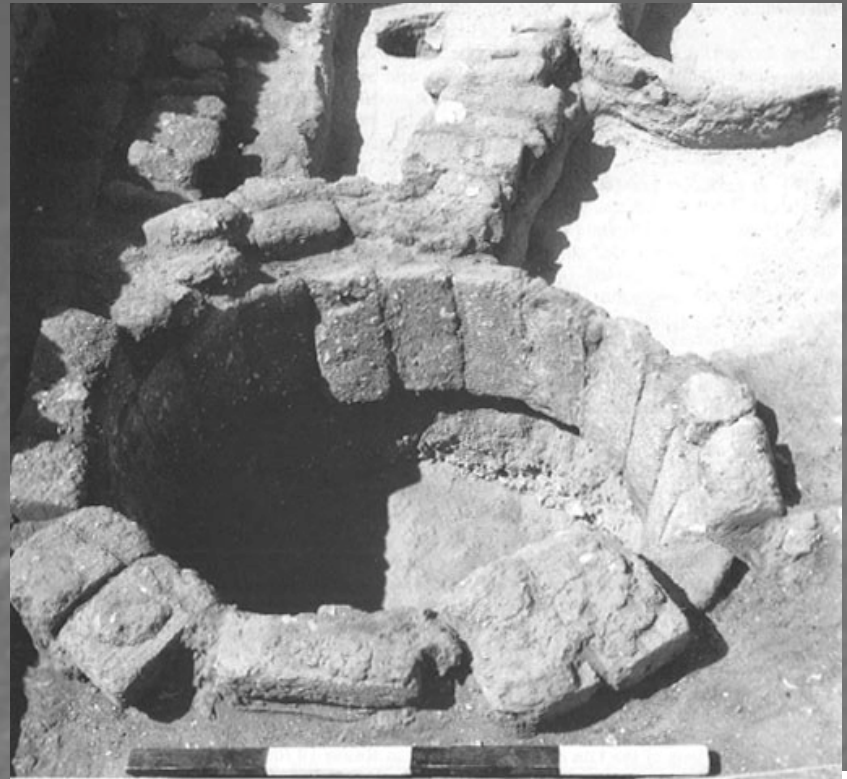
Figure 7.6. View westwards in Raum 10 after final cleaning of kiln.

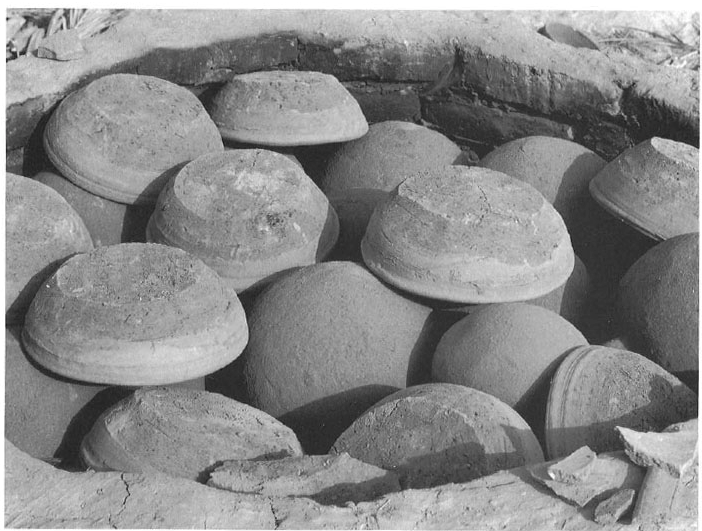
Figure 8.11. The vessels for firing 3, before being covered with sherds.

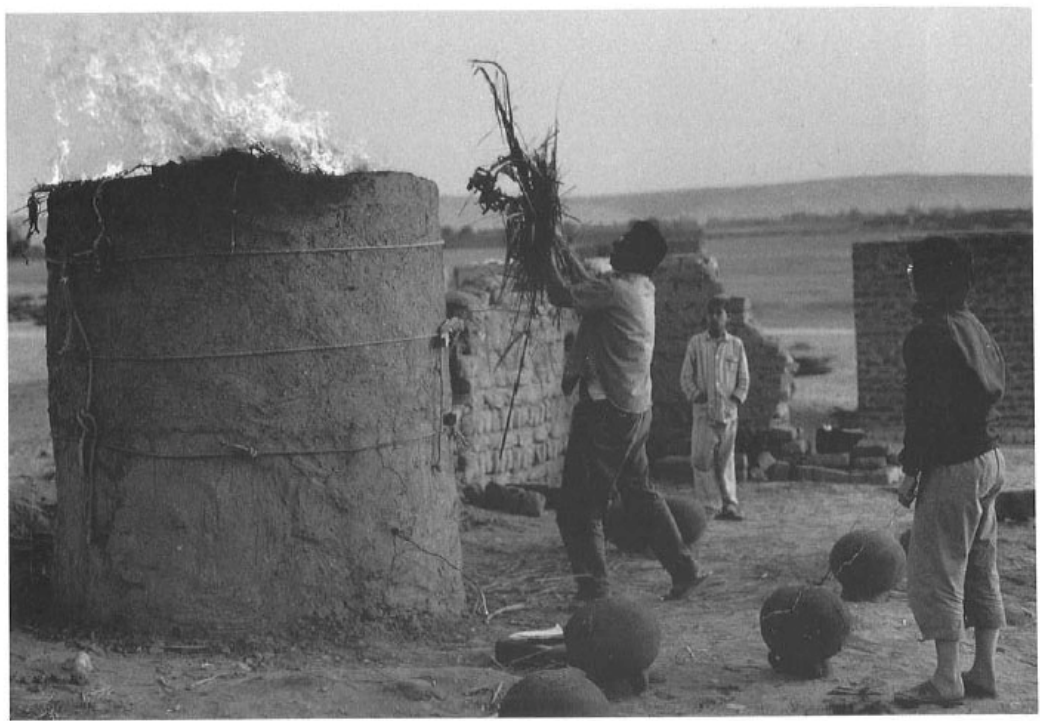
Figure 8.17. Throwing clean fuel onto the kiln top in order to decarbonise it. This marks the final stage in the firing of the kiln.
